## **NPDES Permit Number: MAR10D585**

Project Name: **Route 62 Roadway Resurfacing and Reconstruction**  
Project Address: Route 62 Concord, Massachusetts  
Project Proponent: **Town of Concord Public Works/ MHD**  
Report Prepared By: Mary Trudeau, Environmental Consultant  
Date of Report/Site Visit: November 13, 2009

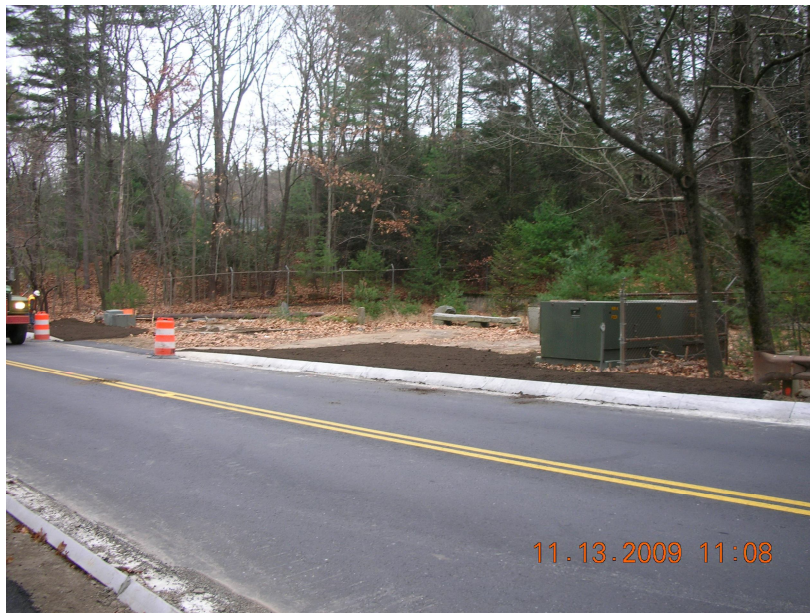
Weather this work week was seasonable with insignificant rainfall during the work week. Heavy precipitation is anticipated over the weekend of November 14, 2009. At the date of my visit on November 13, 2009, it was apparent that work had progressed throughout the week. Work on drainage has continued, with many of the catch basin and manhole structures being uncovered or reset. Curbing work is ongoing, and sidewalk were paved throughout the locus. Driveway aprons are paved, and slopes were being stabilized with screened loam. Construction of the last retaining wall appears to be completed, and the contractor anticipates completion of this phase of the roadwork by the end of November. The following photos show some of the loaming and finish grading ongoing at the date of my visit:

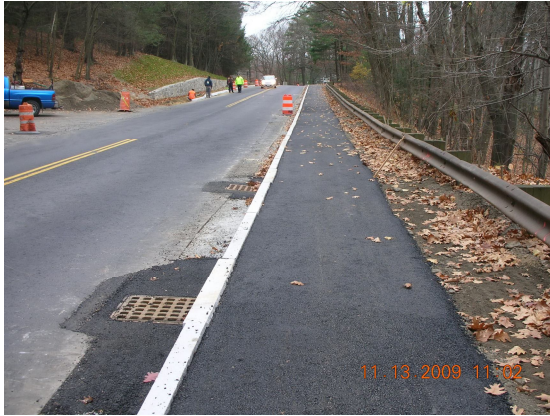
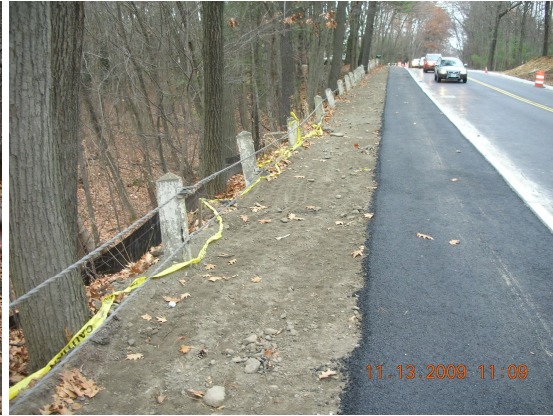
The following photos show two views of the sidewalk work areas located above wetlands on the north side of Route 62. Curbing has been set, and catchbasins uncovered and reset along much of the route. The curbing and sidewalk paving has greatly reduced the unstabilized areas within the locus:

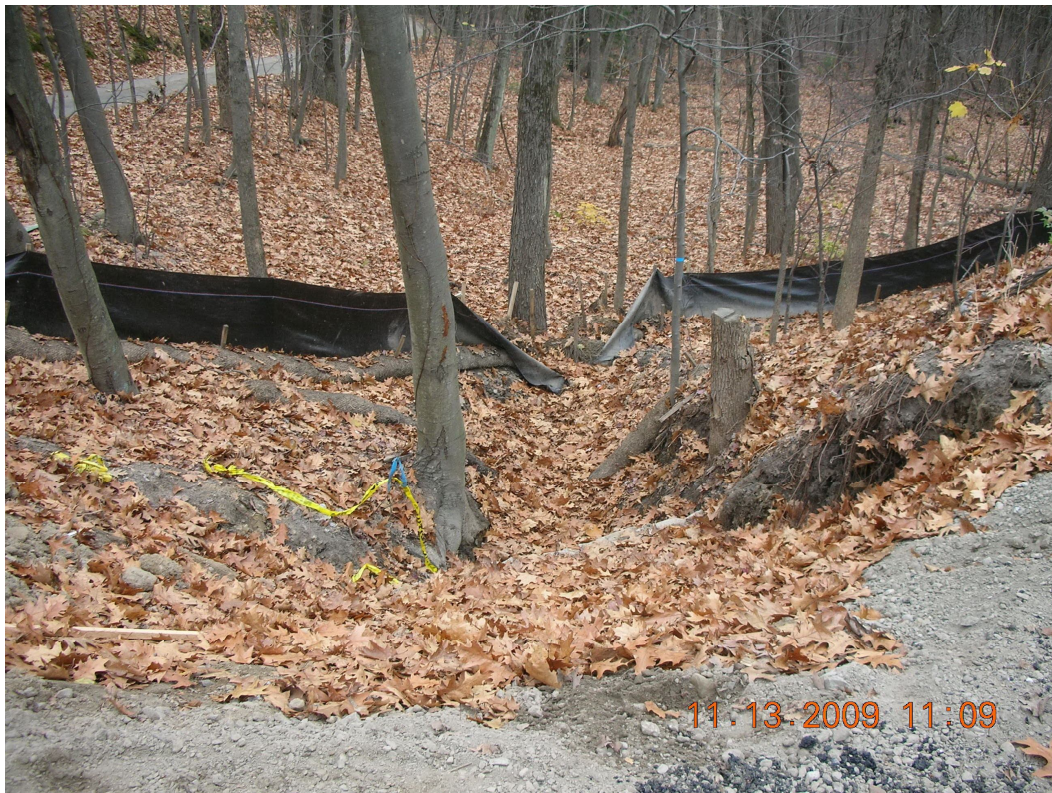
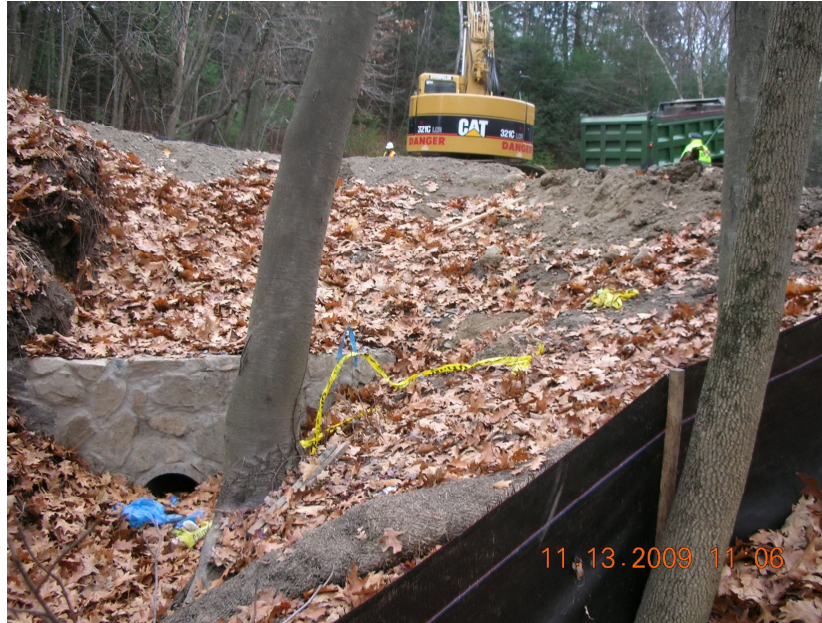
I did have concerns with the condition of the stormwater outfall, located on the north side of Route 62, at station point 23+25. The erosion controls are in poor condition, and the slope above the headwall remains unstable. The following photos show the condition of this area at my most recent site visit. The first photo shows the condition of the erosion controls as viewed from Route 62, and the second photo shows the condition of the unstabilized slope, as viewed from below the outfall:

The contractor should restore the downgradient erosion and sedimentation controls by replacing the torn and damaged silt filter fabric fencing and by replacing the straw wattle with a new wattle or straw bales.

1. The contractor should rebuild the erosion controls at the headwall below station point 23+25 on the north side of Route 62. This should be done immediately.

2. The contractor should stabilize the slopes adjacent to the headwall at station point 23+25, on the north side of Route 62.
3. The contractor should address the sedimentation that has occurred down gradient of the drainage outfall at station point 15+00. Raking and hand work is the appropriate remediation.

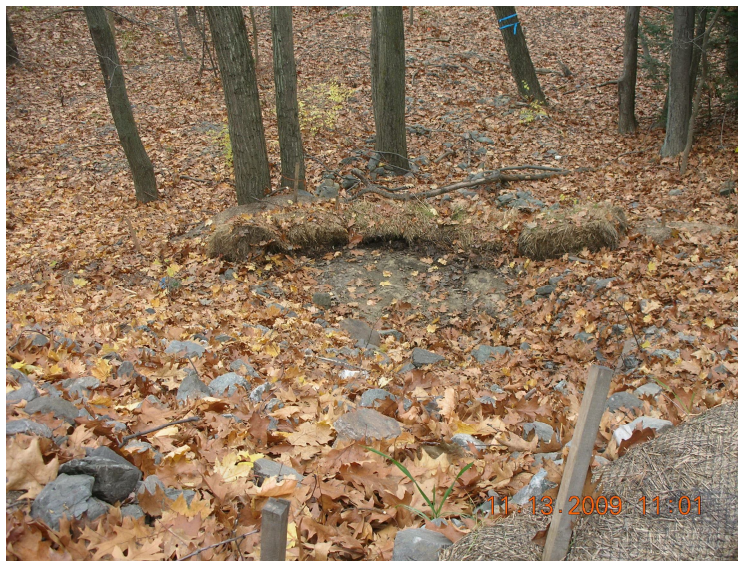
I continue to have some residual concern with the outfall at station point 15+00, on the north side of Route 62. With current pavement grading, the outfall does not appear to be receiving flows from catch basins, but as noted in earlier reports, there has been some historic discharge of sediment to down gradient buffer zone and wetland resource areas. While the accumulations are not significant, the contractor should send a laborer to rake and remove any deposits of material. The following photo shows this area:

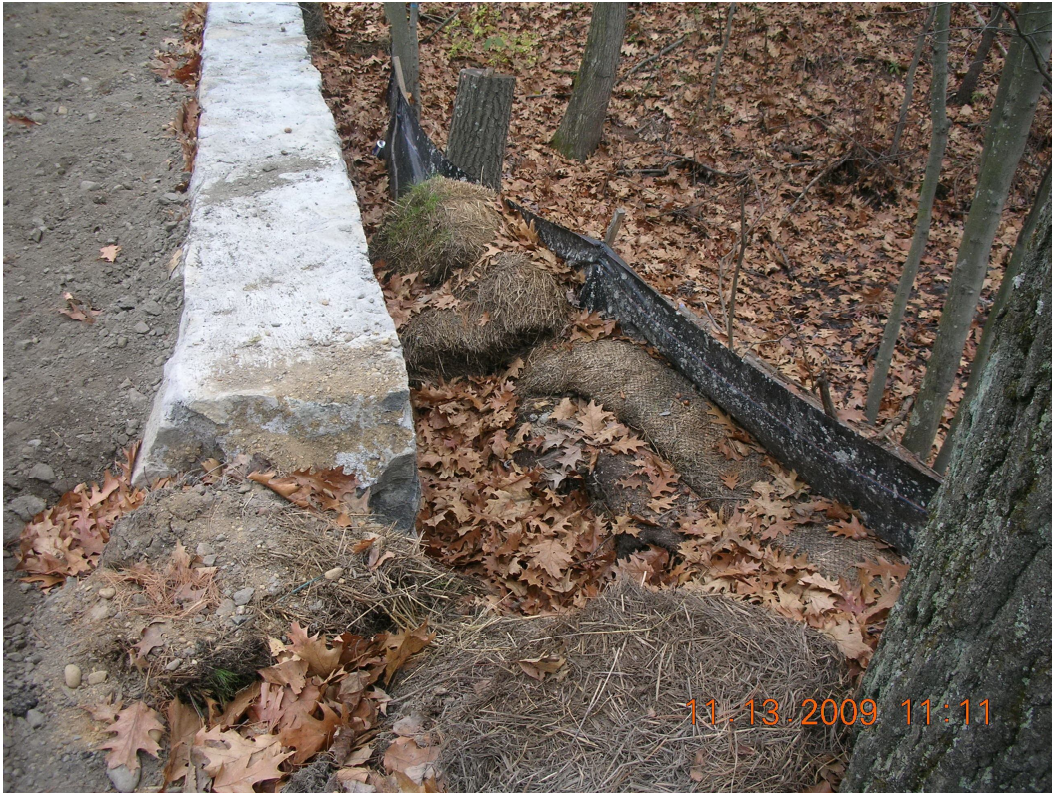
As noted in earlier reports, I am concerned with the upcoming detailing of the slope adjacent to either end of the easternmost retaining wall. This wall is located at approximately station point 27+50, on the south side of Route 62. I have spoken with

Alan Visco of EH Perkins Construction and noted that I am concerned that the work should include stone and hand work to stabilize the area at either end of the wall. The contractor should insure, particularly on the eastern end of the wall (left hand photo below) that the materials used to stabilize the slope utilize the erosion controls for support. The toe of the finished slope should be set, and stabilized, at the back side of the retaining wall, and should not encroach onto the down gradient silt fence barrier. At my visit today I noted that the landscapers had “jammed” haybales into the gap between the wall and the natural slope, and I am hoping that they do not intend to loam and seed on top of the hay bales. This area should be rebuilt with stone not old hay. The following photo shows the areas of concern:

4. The contractor should consider the slope treatment of either end of the retaining wall at station point 27+00, on the southern shoulder of Route 62, and should plan on hand work in the more sensitive areas.

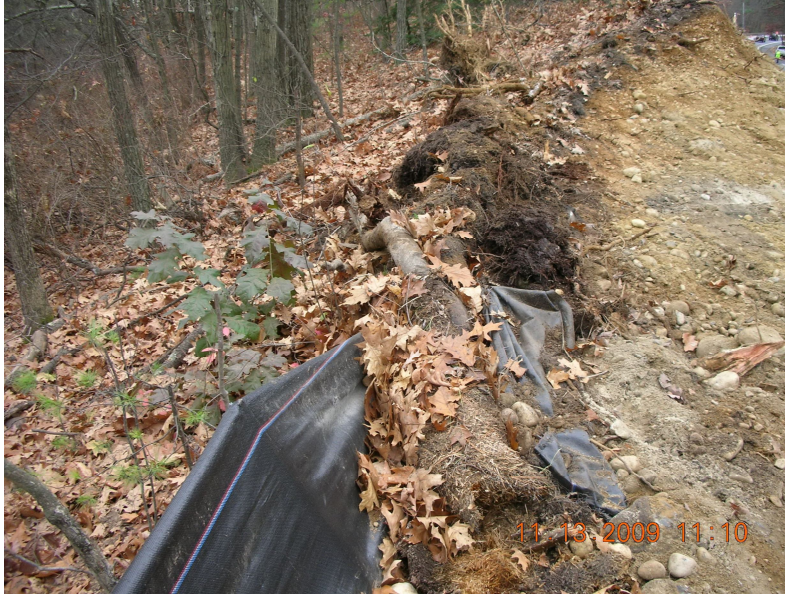
I also noted that some tree roots and other earth materials had been placed on top of siltation control fencing to the west of the retaining wall depicted above. This has damaged the silt fence. The following picture shows the area requiring restoration and removal of the materials:

5. The contractor should remove the debris from the silt fence to the west of station point 27+00. Silt fence should be repaired.
6. The contractor should remove the tree fall at station point 25+75. It should be cut and removed from the site.

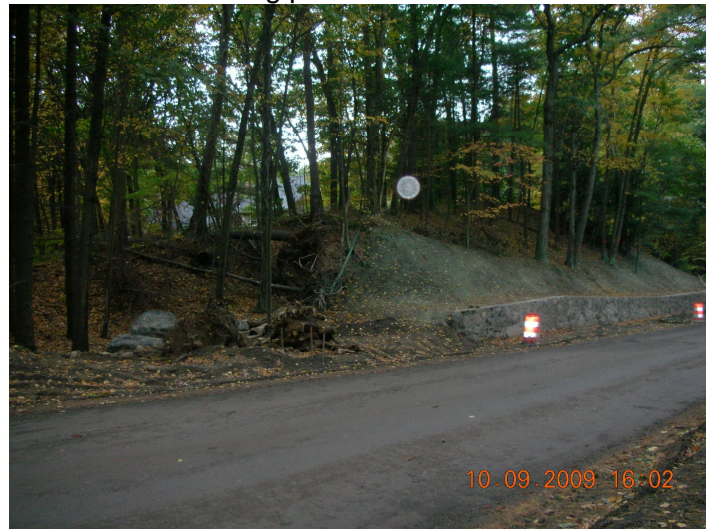
Also noted in earlier reports, Mrs. Sulewski, a condominium owner on Cranberry Lane noted that a tree fall at the south side of Route 62, at approximately station point 25+75 has fallen into and across her yard. Alan Visco and Minot Wood of EHPerkins Construction have determined that the tree fall is within forty feet of the centerline of the road (and is their responsibility) and that it will be cut and removed when the tree cutting crew returns to the site. The following photo shows the tree roots within the job locus:
